ASSEMBLY INSTRUCTION SHEET

XJ AW4 ATLAS II SHIFTER

This Atlas shifter has been designed for the Jeep Cherokee XJ.

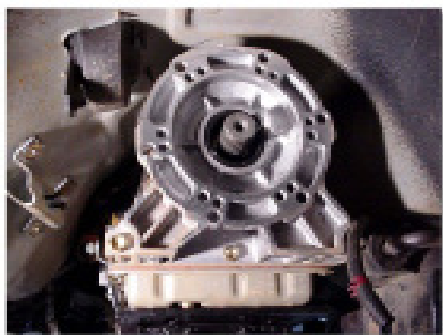
Rear view of the AW4 automatic.

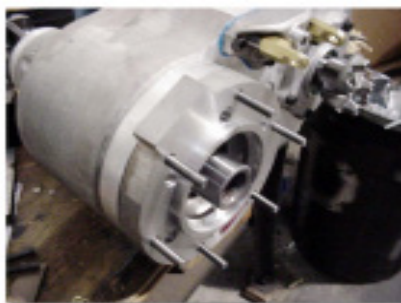
The photo (left) shows the rotation we used to obtain the proper shifter clearance.

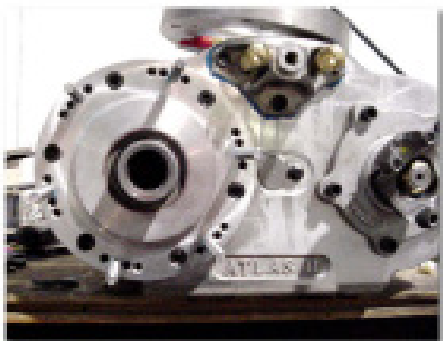
The photo (right) shows the minor body modification made for clearance on the Atlas.

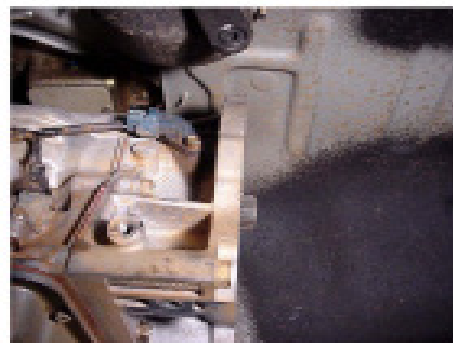
The stock output shaft protrudes .500" past the stock adapter housing. To achieve the proper spline engagement on the Atlas a 1" spacer is required, P/N 51-0404.

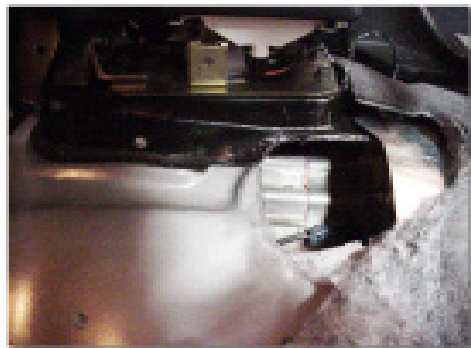
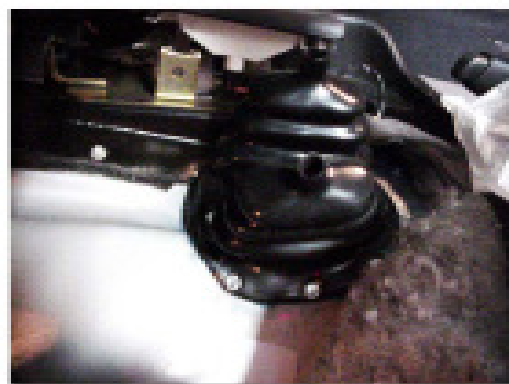
Test fit the Atlas shift handles. If proper clearance has been obtained, screw the rubber boot and ring to the floorboard. Note: The boot ring will need to be cut in half for proper fit to your floorboard.

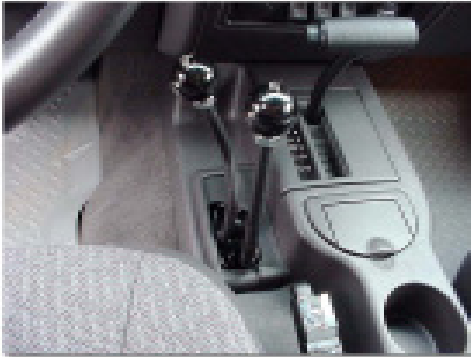
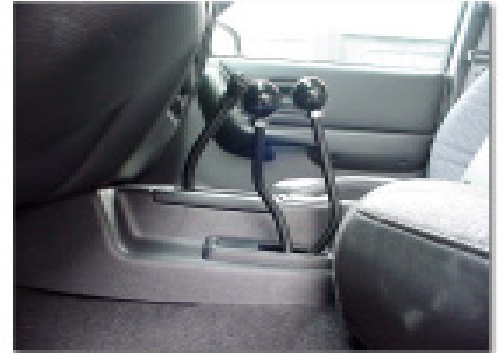
Since the stock transfer case shift indicator cover will not fit with the Atlas twin-sticks, we modified this cover. Remove the indicator panel and cut the plastic that supported the indicator panel. Ideally the plastic housing that snaps into the console is what your trying to retain. We purchased a small piece of black plastic

from a local stereo installation shop and cut it to fit our plastic housing. We heated it to fit the contour and glued it into position. We then cut new access holes in the black plastic to fit our twin sticks.
